BELZONA® 6111 PROTECTION OF FIRE HYDRANTS

ID: 206

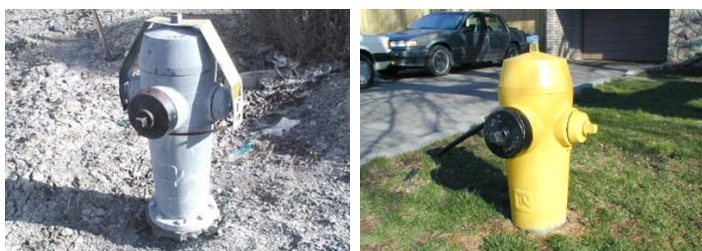
- * Hydrant with Belzona® 6111 applied ,
- * Completed application with top coat of paint applied ,

Application carried out in accordance with a modified version of Belzona Know-How System Leaflet TCC-5, before overpainting with required color top coat.

Customer carried out tests and found Belzona® 6111 to be the most effective system. Previous annual painting has been extended beyond five years.
