BELZONA® 1341 IMPROVES SWIMMING POOL PUMP PERFORMANCE

Industry: Water / Wastewater
Application: CEP-Centrifugal Pumps
Substrate: Cast Iron casing / Bronze impeller
Products: * Belzona® 1311 (Ceramic R Metal) ,
* Belzona® 1341 (Supermetalgilde) ,

Customer Location: Swimming Pool, BC, Canada
Application Date: August 2006

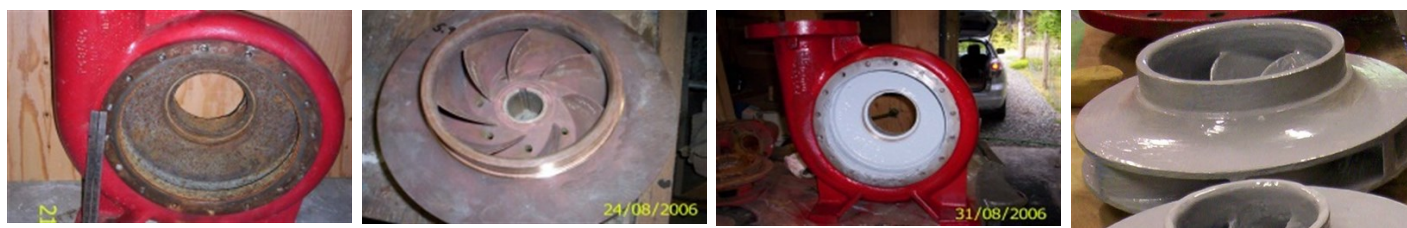
Erosion corrosion, aggravated by galvanic corrosion and corrosion from pool chemicals had reduced pump performance.

- * Pump casing prior to application ,
- * Impeller prior to application ,
- * Pump casing after application of Belzona® 1341 ,
- * Pump impeller after application of Belzona® 1341 ,

Application was carried out in accordance with a Belzona Know-How System Leaflet CEP-1 & 10.

Apart from the general erosion corrosion problems experienced with swimming pool pumps, improving pumping efficiency and reducing running costs were becoming more important as energy costs continue to escalate. An application of Belzona® 1341 Supermetalgilde to the internal surfaces of the pump increased the efficiency by almost 12%.
