# BELZONA® 1341 IMPROVES SWIMMING POOL PUMP PERFORMANCE

**Industry:** Water / Wastewater  
**Application:** CEP-Centrifugal Pumps  
**Substrate:** Cast Iron casing / Bronze impeller  
**Products:** \* Belzona® 1311 (Ceramic R Metal) ,  
\* Belzona® 1341 (Supermetalgilde) ,

**Customer Location:** Swimming Pool, BC, Canada  
**Application Date:** August 2006

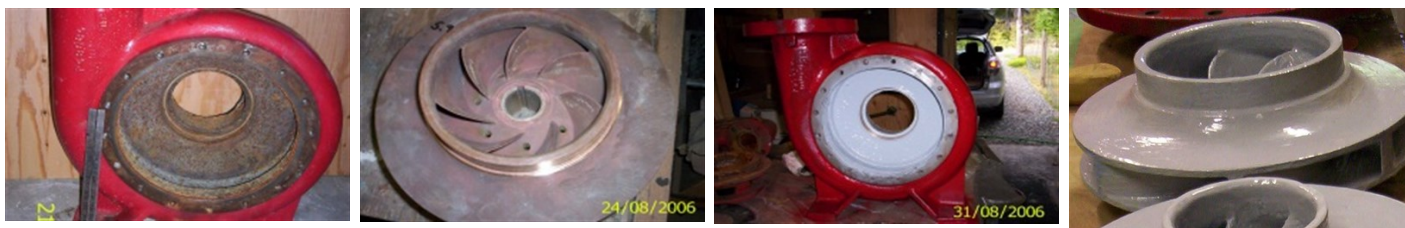
*Erosion corrosion, aggravated by galvanic corrosion and corrosion from pool chemicals had reduced pump performance.*

- \* Pump casing prior to application ,
- \* Impeller prior to application ,
- \* Pump casing after application of Belzona® 1341 ,
- \* Pump impeller after application of Belzona® 1341 ,

Application was carried out in accordance with a Belzona Know-How System Leaflet CEP-1 & 10.

Apart from the general erosion corrosion problems experienced with swimming pool pumps, improving pumping efficiency and reducing running costs were becoming more important as energy costs continue to escalate. An application of Belzona® 1341 Supermetalgilde to the internal surfaces of the pump increased the efficiency by almost 12%.
