BELZONA REDUCES COST OF EXPANSION JOINT REFURBISHMENT

ID: 2085

Customer Location: Public Recreation Facility, BC, Canada
Application Date: March 1997

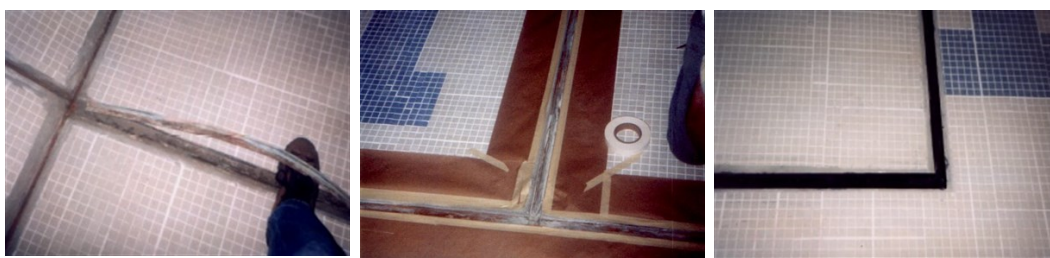
Photograph Descriptions

Deterioration of expansion joints were a constant problem. This facility would budget annually for the replacement of expansion joint material. This repetitive repair and refurbishment work was creating a constant drain on the annual maintenance budget.

- * General view of deteriorated expansion joint ,
- * Application in progress ,
- * View of a completed expansion joint section ,

The original expansion joint material had failed and no longer provided a seal between the various slabs of concrete.

Application carried out in accordance with Belzona Know-How System Leaflet FPA-6.

After the installation of the Belzona Elastomer joints, annual refurbishment of the expansion joints was eliminated. These joints are now 7 years old and still providing protection
