BELZONA SEALS ACCESS RAMP LEAKS

ID: 2086

Customer Location: Recreation Center, BC, Canada
Application Date: September 2002

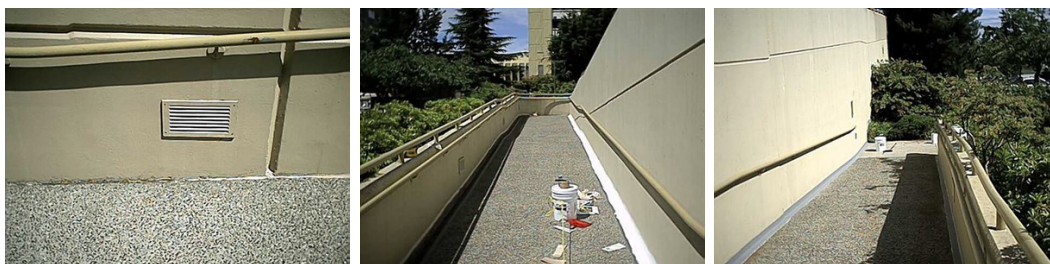
Photograph Descriptions

The caulking between the walls and ramp base needed to be replaced on a regular basis to prevent water from entering into the area below.

- * View of joint to be sealed ,
- * Application of 1st coat of Belzona® 3111 incorporating Reinforcement Sheet ,
- * Completed application ,

Water was entering the storage and equipment areas below.

Application carried out in accordance with Belzona Know-How System Leaflet RPA-1.

Belzona® 3111 Flexible Membrane was used to create a flexible flashing between the wall and floor eliminating the previous repetitive maintenance with sealants.
