# BELZONA PROTECTS STRIPPER TOWER

**Industry:** Chemical & Petrochemical  
**Application:** TCC-Tanks and Chemical Containment Areas  
**Substrate:** Steel  
**Products:** \* Belzona® 1591 ,

**Customer Location:** Chemical Plant in Scotland  
**Application Date:** October 1998

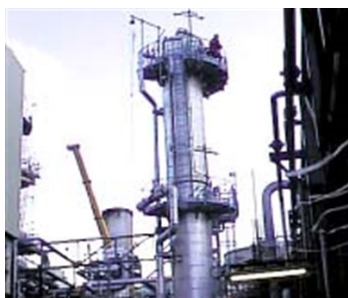
*Erosion/corrosion caused by steam together with chlorides and other impurities.*

- \* General view of the Stripper Tower ,
- \* Application underway in the confined space of the Tower ,
- \* Application continues ,

Original glass flake lining failed and protection required to keep the tower in service to next major shut-down.
