# BELZONA REPAIRS LEAKS IN TANK WELDS

**Industry:** Chemical & Petrochemical  
**Application:** TCC-Tanks and Chemical Containment Areas  
**Substrate:** Stainless steel  
**Products:** \* Belzona® 1111 (Super Metal) ,  
\* Belzona® 4341 ,

**Customer Location:** Petrochemical Plant in Brazil  
**Application Date:** October 2000

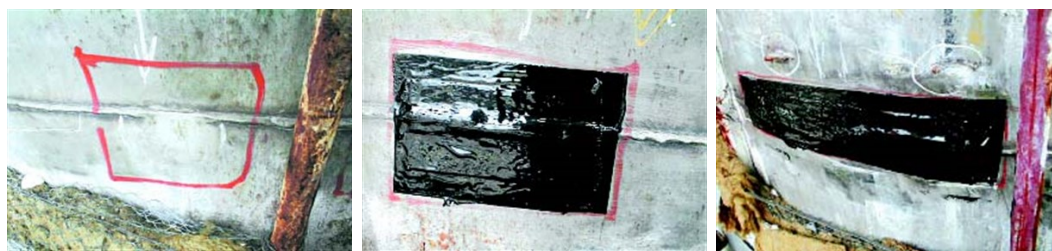
There were leaks at several weld points.

- \* Weld seam prior to application ,
- \* A completed patch ,
- \* Another completed patch with two more suspect areas circled above it ,

The application was carried out in accordance with a modified version of Belzona Know-How System Leaflets TCC-1 and -3.

The company only has one tank like this operating at 90°C, Belzona® 1111 (Super Metal) was applied initially as a sacrificial barrier to give Belzona® 4341 time to cure. The application was accomplished in one day. The alternative was 7 to 8 days of downtime.
