BELZONA PROTECTS NEW STAINLESS STEEL CONES

ID: 213

Industry: *Power*
Application: *SHM-Solids Handling Machinery*

Customer Location: *Power Plant in Florida, U.S.A.*
Application Date: *October 2000*

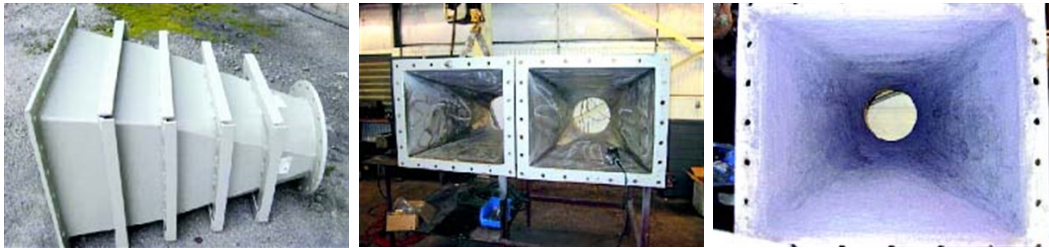
Photograph Descriptions

Impact and abrasion from coal, coupled with high temperatures caused severe wear to the cone walls.

- * New cone prior to application ,
- * Blasted cones ,
- * Protected cone with Belzona® 1812 that is ready for service ,

The application was carried out in accordance with Belzona Know-How System Leaflet SHM-13.

The plant had been replacing the cones every five years with difficult access. Belzona® 1812 offered great flexibility to their program by providing long term protection against premature wear.
