# BELZONA RESTORES CRITICAL TOLERANCES IN LIQUID RING VACUUM PUMP

ID: 2154

Industry: *Pulp & Paper*  
 Application: *FBC-Fans, Blowers and Compressors*

Customer Location: *Paper mill, Australia*  
 Application Date: *December 2005*

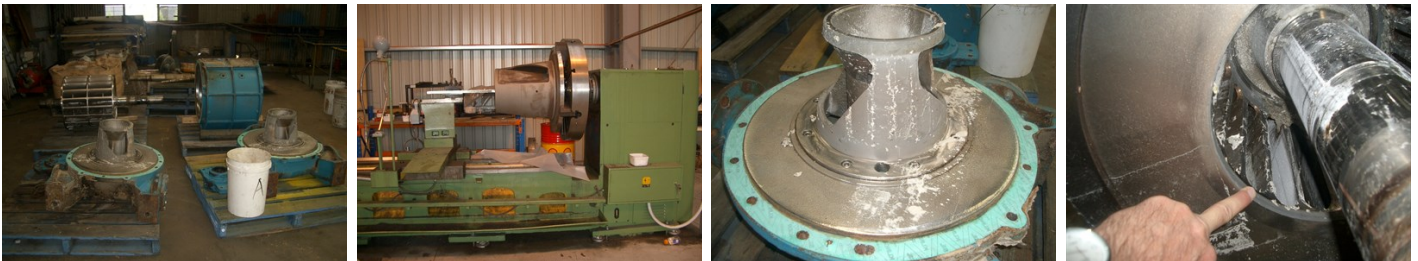
*The pump is subjected to corrosion and “carry over” of the paper pulp. The tolerance between the outside diameter of the cone and the internal taper of the rotor was no longer correct, due to the wear on the cone flange, clearly visible near the bolt holes.*

- \* A dismantled vacuum pump from Paper Mill ,
- \* Cone from 14,000 CFM vacuum pump undercut prior to the application ,
- \* The stainless steel cone repaired with Belzona® 1111 after 4 years in service ,
- \* The stainless steel rotor is showing significant wear, whereas the Belzona® 1111 applied to the adjacent cone is not ,

Application was carried out in accordance with Belzona Know-How System Leaflet FBC-10. The stainless steel cone in this pump was rebuilt with Belzona® 1111 and machined to correct dimensions and taper angle.

The pump cone was inspected after 4 years in service. Despite the aggressive conditions, the Belzona® 1111 is showing virtually no wear. The stainless steel rotor is showing significant wear whereas the Belzona® 1111 applied to the adjacent part (the cone) is not.
