# BELZONA SAVES REPLACEMENT COSTS

Industry: *Mining & Quarrying*  
Application: *MPT-Mechanical Power Transmission*

Customer Location: *Quarry in Germany*  
Application Date: *November 1999*

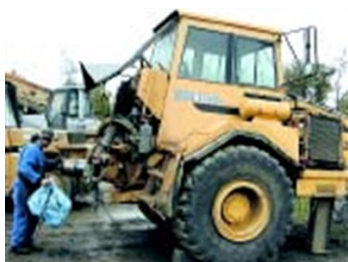
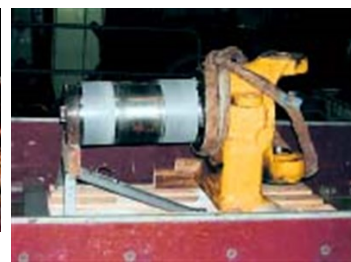
*The ends of the shaft were worn due to play in the joint.*

\* The power unit The damaged shaft Application of the Belzona® 1111 underway The completed repair ,

Universal joint between power unit and trailer of articulated earth mover.

The application was carried out in accordance with Belzona Know-How System Leaflet MPT-1.

The Belzona repair saved replacement costs estimated at \$7,250 plus delays in sourcing the parts. The Belzona repair allowed the equipment to continue in service with minimal interruption to production.
