# BELZONA SAVES REPLACEMENT COSTS

ID: 216

Industry: *Mining & Quarrying*  
Application: *MPT-Mechanical Power Transmission*

Universal joint between power unit and trailer of articulated earth mover.

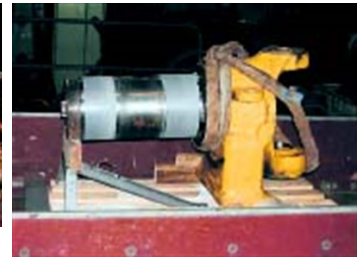
*The ends of the shaft were worn due to play in the joint.*

\* The power unit The damaged shaft Application of the Belzona® 1111 underway The completed repair ,

The application was carried out in accordance with Belzona Know-How System Leaflet MPT-1.

The Belzona repair saved replacement costs estimated at \$7,250 plus delays in sourcing the parts. The Belzona repair allowed the equipment to continue in service with minimal interruption to production.
