BELZONA RAPID REPAIR TO VIADUCT RAILING SUPPORT

ID: 2161

Customer Location: Town council, Canada

Application Date: May 2003

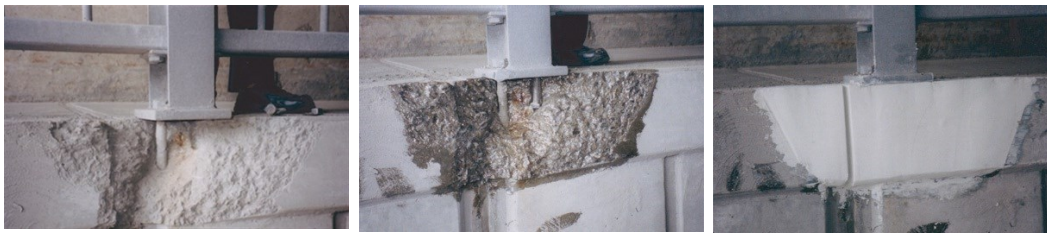
Photograph Descriptions

The concrete base for railings support pillars was cracked and spalled.

* Concrete condition before the application The concrete is coated with Belzona® 4911 Conditioner Belzona® 4141 application completed quickly and easily without the use of formwork ,

Application was carried out in accordance with Belzona Know-How System Leaflet FPA-10.

The application was achieved in 2 hours and without the need for any formwork. This application is still in excellent condition when inspected in 2011.
