BELZONA PROVIDES PROTECTION FROM HOT GASES AT WATER TREATMENT PLANT

ID: 2167

Customer Location: Water treatment plant, Slovakia
 Application Date: March 2011

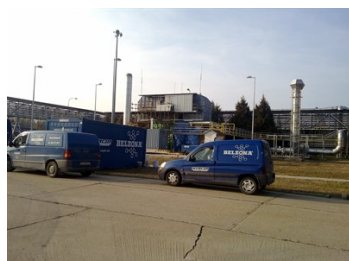
- * General view of the reactor ,
- * Corrosion before repair ,
- * After grit blasting pitting corrosion clearly evident ,
- * Inspection after 6 months showed no damage or defects on the coating ,

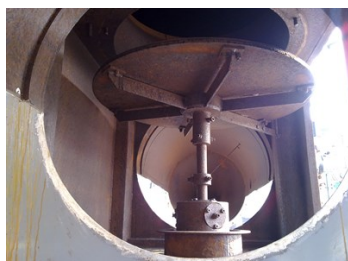
Sulphides, Sulphates, Chlorides, Ammonia, etc. in the gas caused pitting corrosion in the unit after 10 months.

Application was carried out in accordance with Belzona Know-How System Leaflet TCC-5. After grit blasting and chemical cleaning, areas were coated with Belzona® 1392 or Belzona® 4311 (depending on temperature).
