BELZONA KEEPS WORN HOSE WORKING

Industry: General Industry
Application: SOS-Ships and Offshore Structures

Customer Location: Shipping company in Canada
Application Date: November 2000

Substrate: Rubber
Products: * Belzona® 2311 (SR-Elastomer),

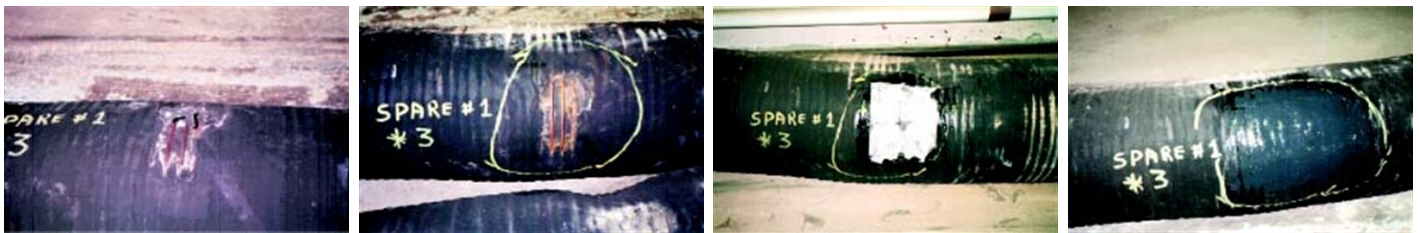
The uploading cement hose had worn through to the reinforcement wire.

- * Overview of damaged area ,
- * Loose pieces have been removed ,
- * The conditioner, reinforcement sheet and Belzona® 2311 (SR-Elastomer) have been used to fill area ,
- * The finished repair ,

Worn rubber hose

Application was carried out out in accordance with Belzona Know-How System Leaflet SOS-12.

A quick reliable repair was required and other than replacement, Belzona was the only option.
