BELZONA REPAIRS AND PROTECTS HYDROELECTRIC TURBINE AND CASING

ID: 2202

Hydroelectric pumped storage turbine and casing

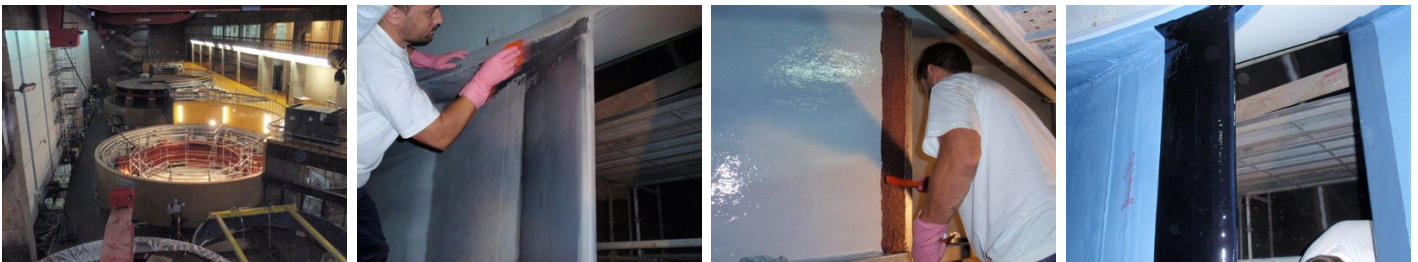
Photograph Descriptions

Both turbine and casing suffered from severe erosion corrosion when operating in both pumped storage and electricity generation mode.

* Turbine disassembly Pit filling on the turbine with Belzona® 1111 Application of Belzona® 1812 after coating the entire stay vane with Belzona® 1341 Completed application of Belzona® 2141 ,

Application was carried out in accordance with Belzona Know-How System Leaflets CEP-3, CEP-5 & SHM-11. The application was carried out on a platform built on the ground floor, which provided more space and a more controlled application environment. Belzona® 1321 was applied to protect from future erosion corrosion damage. Within localised problem areas, a number of different systems were used. Belzona® 1812 was applied to the stay vanes' leading edges for protection from entrainment erosion in pumping mode, and Belzona® 2141 on the stay vanes' leading edges in turbine mode to protect from cavitation with Belzona® 1341 being used in the middle section.

Thanks to the use of various Belzona systems in localised areas, a number of different problems could be addressed, demonstrating the versatility of Belzona products. Inspection in June 2012 showed all application areas to be in excellent condition with no evidence of corrosion or erosion on the different application areas.
