# BELZONA® 1811 PROTECTS BEET FLUME WELD JOINTS

Industry: *Sugar*  
Application: *SHM-Solids Handling Machinery*  
Substrate: *Stainless steel plate*  
Products: *\* Belzona® 1811 (Ceramic Carbide),*

Customer Location: *Sugar factory in the United Kingdom*  
Application Date: *1999*

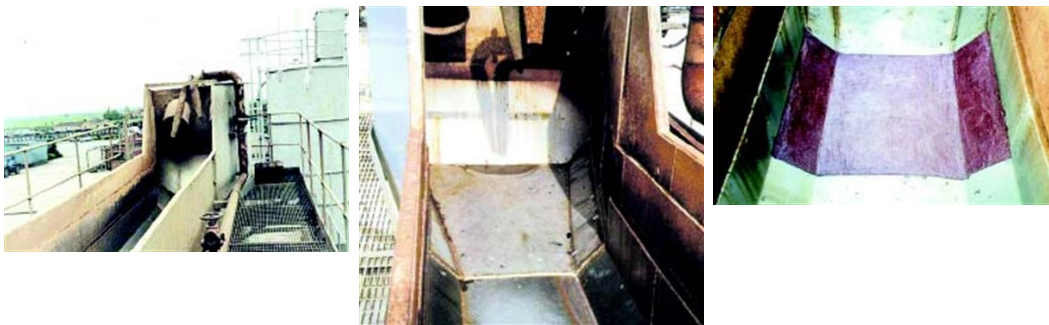
*Extensive abrasion and eventual failure of the weld seams connecting the steel plates that make up the flume.*

- \* General view of the application site ,
- \* Equipment prior to surface preparation ,
- \* Application completed with the Belzona® 1811 ,

Abrasion of the weld seams - if allowed to continue - would have led to impaired operating efficiency. Repair or replacement during the manufacturing campaign would have required significant downtime and resulted in a major loss of revenue. Belzona product lent itself to application within the confines of the flume channel. By applying Belzona to seams in the flumes most vulnerable areas during annual outage, only sacrificial wear of the product takes place during the campaign, thereby leaving the weld seams intact.
