BELZONA REFURBISHES EIGHTY YEAR OLD TURBINE RUNNER

ID: 2254

Customer Location: Hydro-electric plant, Arkansas
Application Date: 2008

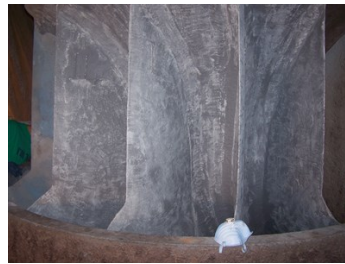
Years of use had caused severe corrosion and cavitation erosion on the turbine. Customer had received bids for new replacement but chose Belzona on economic grounds.

- * Turbine before initial blast cleaning ,
- * Some of the cavitation damage ,
- * Project after Belzona® 1121 application ,
- * Completed project ,

Severely eroded Francis turbine runner.

Application was carried out in accordance with Belzona Know-How System Leaflets CEP-3 & CEP-5. Corroded surfaces were rebuilt and smoothed with Belzona® 1121 before coating with Belzona® 1341 for long term protection.
