BELZONA PROTECTION OF RISER BEND

ID: 2258

Industry: Oil & Gas
Application: VPF-Valves, Pipes and Fittings
Substrate: Aluminium Bronze
Products: * Belzona 1311 (Ceramic R-Metal) ,
* Belzona 1321 (Ceramic S-Metal) ,

Customer Location: North Sea, Norway
Application Date: January 2011

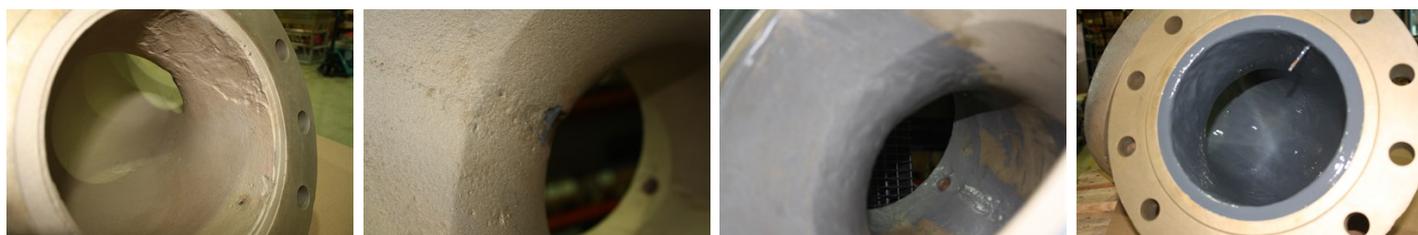
Photograph Descriptions

The riser bend was suffering from internal erosion corrosion.

- * Riser bend overview ,
- * Internal Erosion Corrosion ,
- * Corroded areas rebuilt with Belzona® 1311 ,
- * Application completed with Belzona® 1321 applied ,

Application was carried out in accordance with Belzona Know-How System Leaflet VPF-1 & VPF-2. Following gritblasting all corroded areas were rebuilt using Belzona® 1311. Two coats of Belzona® 1321 were then applied to complete the application.
