# BELZONA SAVES SLUDGE PUMP

Customer Location: Wastewater treatment plant in Virginia, U.S.A.

Application: CEP-Centrifugal Pumps

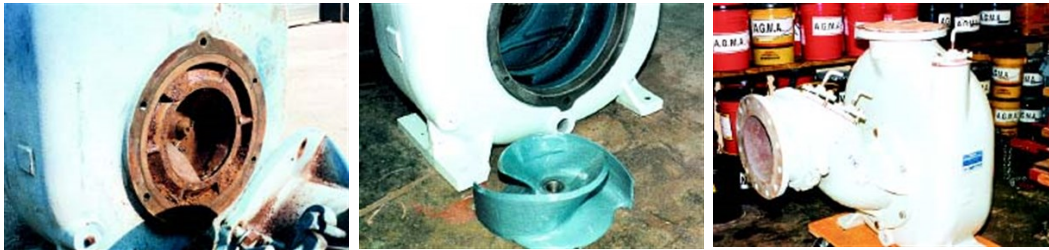
Impeller was frozen by rust. It would not turn.

- \* Rusty impeller, frozen in place. ,
- \* Impeller and internal casing coated with Belzona® 1321 erosion- corrosion resistant coating. ,
- \* The refurbished pump ready for service. ,

Badly corroded sludge pump.

The application was carried out in accordance with Belzona Know-How System Leaflet CEP-5.

In the past this pump would have been scrapped and replaced at a cost of \$6,500. The Belzona repair cost \$985, thus saving the customer over \$5,500 and providing additional years of service.
