BELZONA REPAIRS LARGE SOOT BLOWING AIR COMPRESSOR

ID: 231

Customer Location: Coal fired power plant in Texas, U.S.A.
Application Date: October 1999

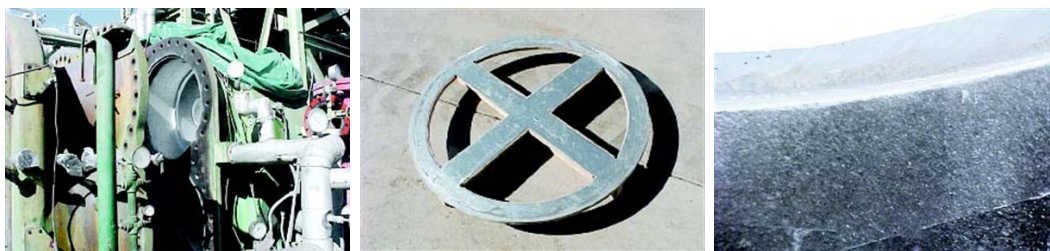
Photograph Descriptions

Corrosion in water jacket area had reduced the gasket sealing surface and allowed water into the air stream.

- * Overall view of soot blowing air compressor ,
- * Mold used to help form overlay for correct fit ,
- * Finished sealing area, lighter color (top) shows Belzona® 1111 (Super Metal), darkest color is existing cast iron ,

Repair to soot blowing air compressor operating at 12,500 cfm.

The application was carried out in accordance with Belzona Know-How System Leaflet GSS-7. This method included grit blasting the area to be built up. A mold was used to help form the correct fit and a disc sander was used to achieve the proper finish.
