# BELZONA OFFERS COLD REPAIR SOLUTION TO PIPEWORKS

**Industry:** Oil & Gas  
**Application:** VPF-Valves, Pipes and Fittings  
**Substrate:** Carbon steel  
**Products:** \* Belzona® 1121 (Super XL Metal) ,  
 \* Belzona® 5811 (Immersion Grade) ,

**Customer Location:** Refinery in France  
**Application Date:** 2006

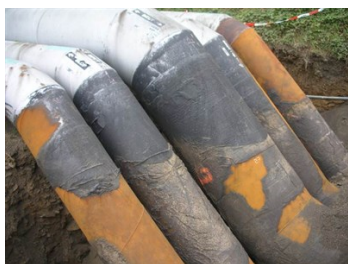
*Previous coating did not last and external corrosion of the pipework was extensive.*

- \* Failure of the previous coating ,
- \* Repair using Belzona® 1121 and reinforcement tape ,
- \* Extra corrosion protection being provided with Belzona® 5811 coating ,
- \* Repair completed ,
