BELZONA OFFERS COLD REPAIR SOLUTION TO PIPEWORKS

ID: 2316

Application: VPF-Valves, Pipes and Fittings

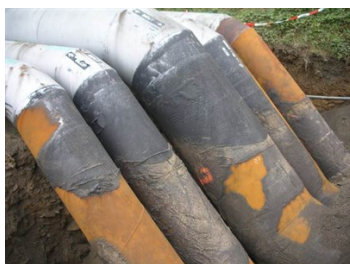
Previous coating did not last and external corrosion of the pipework was extensive.

- * Failure of the previous coating ,
- * Repair using Belzona® 1121 and reinforcement tape ,
- * Extra corrosion protection being provided with Belzona® 5811 coating ,
- * Repair completed ,

Following a surface preparation done by hydroblasting, the repair was carried out in accordance with Belzona Know How System Leaflet VPF-11a.
