BELZONA OFFERS COLD REPAIR SOLUTION TO PIPEWORKS

ID: 2316

Customer Location: Refinery in France

Application: VPF-Valves, Pipes and Fittings

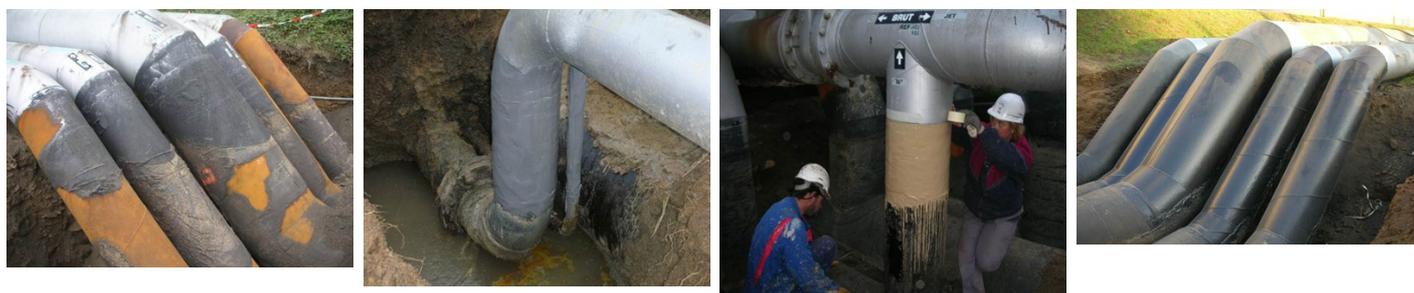
Photograph Descriptions

Previous coating did not last and external corrosion of the pipework was extensive.

- * Failure of the previous coating ,
- * Repair using Belzona® 1121 and reinforcement tape ,
- * Extra corrosion protection being provided with Belzona® 5811 coating ,
- * Repair completed ,

Following a surface preparation done by hydroblasting, the repair was carried out in accordance with Belzona Know How System Leaflet VPF-11a.

Given the environment, a hot repair was not an option. Belzona's cold application techniques allowed the customer to repair and protect these pipes using a sandwich material made of resins and reinforcement tape. The repair was inspected in 2011 and remained in perfect condition. Since 2006, many more pipes have been repaired using this technique.
