BELZONA REPAIRS WASTEWATER PUMP

Customer Location: Wastewater treatment facility -
Vancouver, Canada.

Application: CEP-Centrifugal Pumps

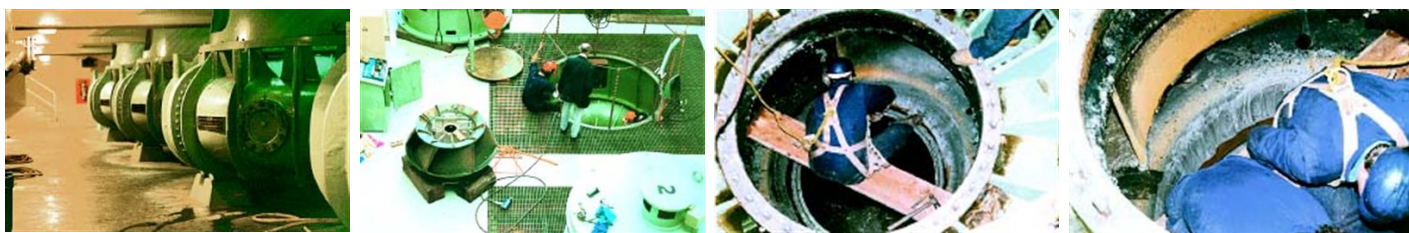
Photograph Descriptions

Pumps were suffering from severe erosion around the volute. It was difficult to remove the unit for repair due to its size and location.

- * Large centrifugal pumps ,
- * Pumps disassembled for repair ,
- * Volute rebuilding in progress ,
- * Rebuilding in progress ,

Large six foot diameter centrifugal pumps.

Application was carried out out in accordance with a modified version of Belzona Know-How System Leaflet MPT-2.

Pumps were opened five years after application and were in perfect condition.
