## BELZONA LEVELS LOADING QUAY

ID: 2365

Industry: Buildings & Structures  
 Application: FPA-Floor Problem Areas  
 Substrate: Concrete  
 Products: \* Belzona® 4111 (Magma-Quartz),

Customer Location: Animal feed manufacturer, Canada  
 Application Date: November 2006

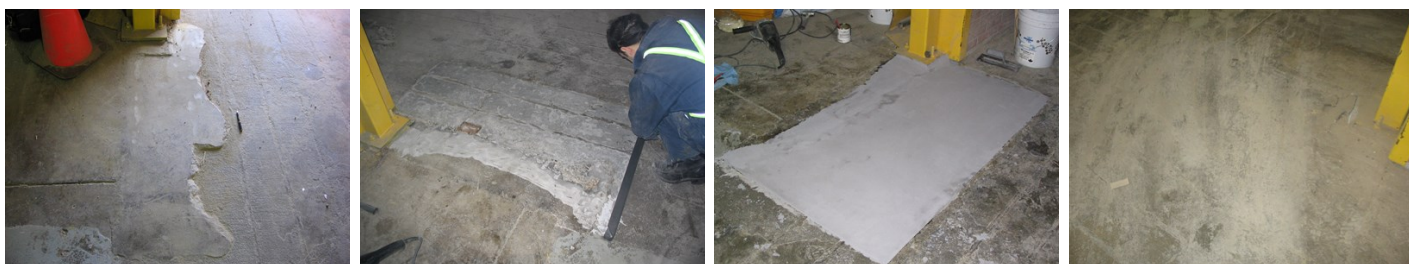
The uneven surface (measuring 1 inch) between two concrete sections was causing impact problems to forklift trucks driving through. The impact caused pain to the personnel operating these trucks, as well as jeopardising the balance and security of the loads.

- \* The failed previous alternative repair ,
- \* Surface preparation ,
- \* Completed application ,
- \* Application after 1 year ,

A less costly alternative repair had lasted only 6 month (picture 1). Belzona 4111 is still intact after 1 year in service, due to its excellent bond strength, impact resistance and compressive strength.

The application was carried out in accordance with Belzona Know-How System Leaflet FPA-1.
