# BELZONA PRE-STRESSED CONCRETE BEAMS

**Industry:** Oil & Gas  
**Application:** TCC-Tanks and Chemical Containment Areas  
**Substrate:** Pre-stressed concrete  
**Products:** \* Belzona® 4911 (Magma TX Conditioner) ,  
\* Belzona® 4111 (Magma-Quartz) ,

**Customer Location:** Oil Refinery in Canada  
**Application Date:** September 1998

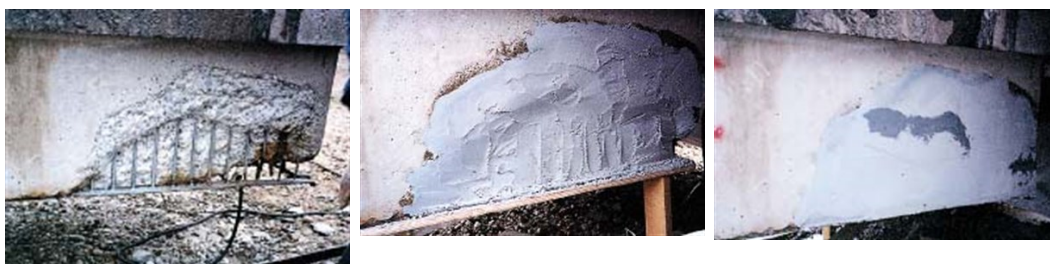
Concrete severely eroded over time.

- \* Area of worst damage, re-bar and bottom metal spine being repaired. ,
- \* Application in progress. Note the polyethylene covered plywood being used as a former. ,
- \* Completed repair. ,

Application was carried out in accordance with a modified version of Belzona Know-How Leaflet TCC-9.

The cost of replacement versus repair of the beams was a key factor. The ability to force-cure the product with heat resulted in reduced downtime.
