BELZONA® 5811: EXCEEDING WHERE OTHERS FAIL

Industry: Power
Application: HEX-Heat Exchangers
Substrate: Carbon steel
Products: * Belzona® 5811 (Immersion Grade) ,

Customer Location: Gas-fired power plant in Midwest, U.S.A.
Application Date: March 2000

G.E. Condenser (Generator) Water Box

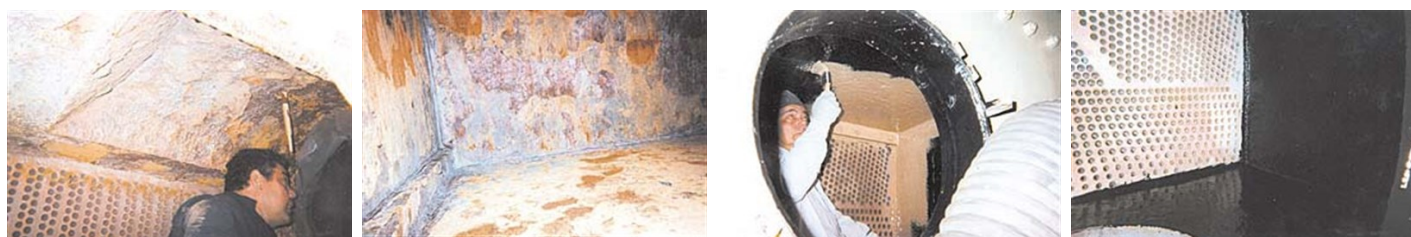
Photograph Descriptions

Previous coatings had failed in a very short time. Loss of imitator coating and severe corrosion were causing the blockage of tubes, thus reducing efficiency of unit.

- * Corroded water box ,
- * Another view of the corrosion ,
- * Belzona® 5811 was brush applied in a two coat process - black over tan ,
- * Completed application of Belzona® 5811 ,

The application was carried out in accordance with Belzona Know-How System Leaflet HEX-3.

After one year of service, only minor touch-ups were required. The power plant superintendent is a very happy customer and the job has led to other applications.
