BELZONA RESTORES FOUR CONDENSER TUBE SHEETS IN FIVE DAYS

ID: 241

Application: HEX-Heat Exchangers

Condenser tube sheets of 350 MW generator - each contains 6, 453 tubes.

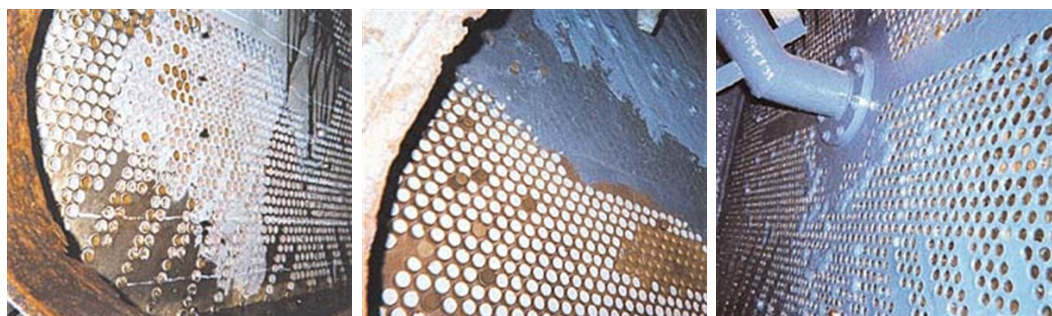
Photograph Descriptions

Insertion of new stainless steel sleeves caused ligament damage to the inlet tube sheets resulting in severe tube to tube sheet leaks and a forced outage.

- * Initial view of bottom of one tube sheet prior to grit blasting ,
- * Application of Belzona® 1121 and Belzona® 1341 underway ,
- * Completed tube sheet ready to go online ,

The application was carried out in accordance with Belzona Know-How System Leaflet HEX-1. The entire application of all four tube sheets, including blasting, occurred within five days with a crew of approximately 28 men.
