# BELZONA CRUSHES ANOTHER PROBLEM

ID: 242

Industry: *Mining & Quarrying*  
Application: *MPT-Mechanical Power Transmission*

Customer Location: *Quarry, Kansas U.S.A.*  
Application Date: *June 1999*

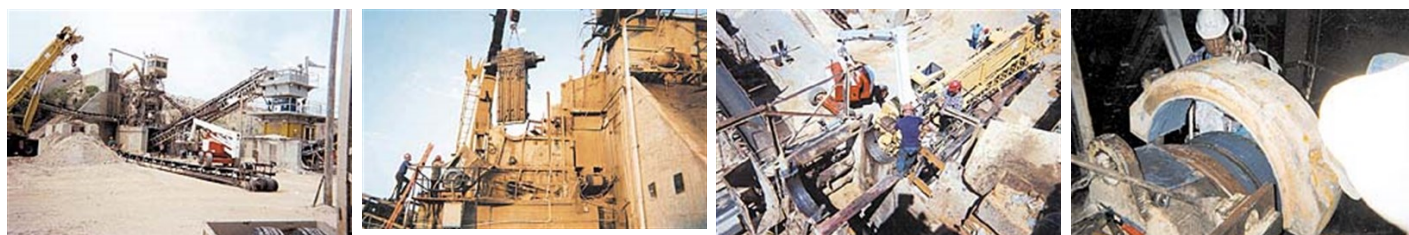
## Photograph Descriptions

*During a maintenance outage, the plants 34-ton rock crusher's main bearing saddles were showing unacceptable levels of wear.*

\* An overview of the quarry An overview of the rock crusher The Belzona® 1121 (Super XL-Metal) being applied The equipment being reassembled ,

The application was carried out in accordance with Belzona Know-How System Leaflet MPT-7 using Belzona® 1121 (Super XL-Metal) due to the extreme summer heat and long time required to "reset" the equipment via crane.
