# BELZONA PROTECTS CYCLONES

ID: 2449

Application: SHM-Solids Handling Machinery

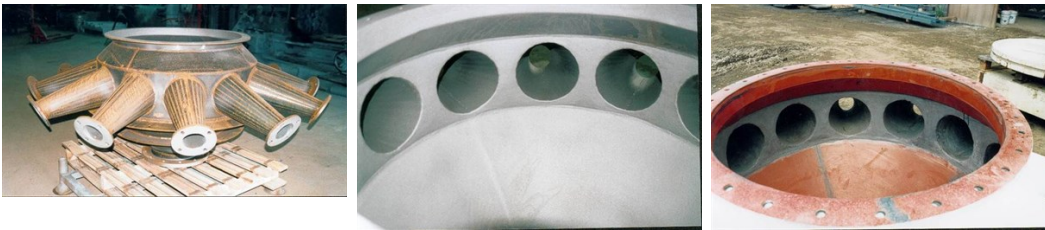
Severe abrasion due to the wet mud. The original bonded rubber lining usually used is difficult to repair insitu due to the complex surface geometry.

- \* Cyclone head ,
- \* Interior of the cyclone after blasting ,
- \* Interior of the cyclone after the application of Belzona® 1812 ,

The Belzona solution allowed repairs to be done insitu minimizing delays to the tunnel boring process. The Belzona® 1812 was easily applied and formed to the complex shape of the centrifuge. No further repairs were required after 2 years in service (2003)
