BELZONA REPAIRS COLLEGE STEPS

Industry: Buildings & Structures
Application: FPA-Floor Problem Areas
Substrate: Concrete
Products: * Belzona® 4131 (Magma Screed) ,
* Belzona® 4411 (Granogrip) ,

Customer Location: College, East Midlands, UK
Application Date: August 2011

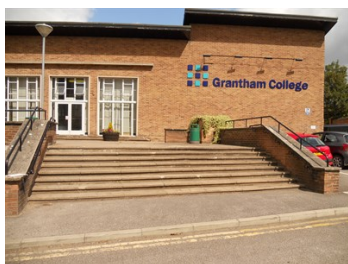
Heavy foot traffic and weathering caused the steps at this college to become damaged and worn.

- * General view of the damaged steps ,
- * First application of Belzona® 4131 ,
- * Application being carried out ,
- * Finished application ,
