# BELZONA REPAIRS ARMY VEHICLE

ID: 2452

Customer Location: British Army, UK  
Application Date: 2010

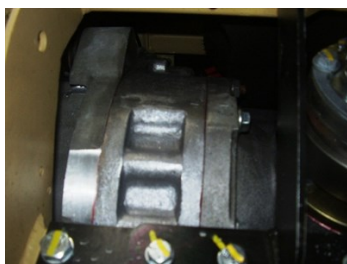
The vehicle's gearbox casting was porous leading to unacceptable oil loss.

- \* The Jackal ,
- \* The porous gearbox casting before application ,
- \* The gearbox sealed with Belzona® 1161 ,
