BELZONA REPAIRS ARMY VEHICLE

ID: 2452

Industry: *Military*
Application: *TCC-Tanks and Chemical Containment Areas*
Substrate: *Cast Aluminium*
Products: ** Belzona® 1161 (Super UW-Metal) ,*

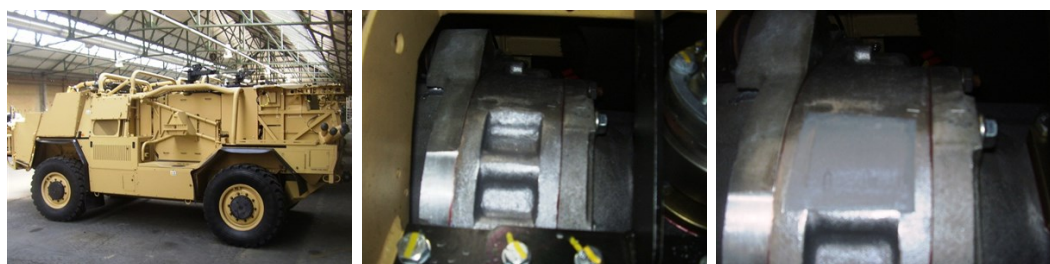
Photograph Descriptions

The vehicle's gearbox casting was porous leading to unacceptable oil loss.

- * The Jackal ,
- * The porous gearbox casting before application ,
- * The gearbox sealed with Belzona® 1161 ,

The Belzona repair was completed without heat and without removing the gearbox. Belzona® 1161 surface tolerant properties makes it ideal for this type of repair where oil contamination may be difficult to completely remove.
