BELZONA PROTECTS PIPELINE AND VALVES FROM CEMENT ABRASION

Industry: *Cement*
Application: *VPF-Valves, Pipes and Fittings*
Substrate: *steel*
Products: ** Belzona® 1811 (Ceramic Carbide) ,*

Customer Location: *Cement producer, Slovakia*
Application Date: *2000*

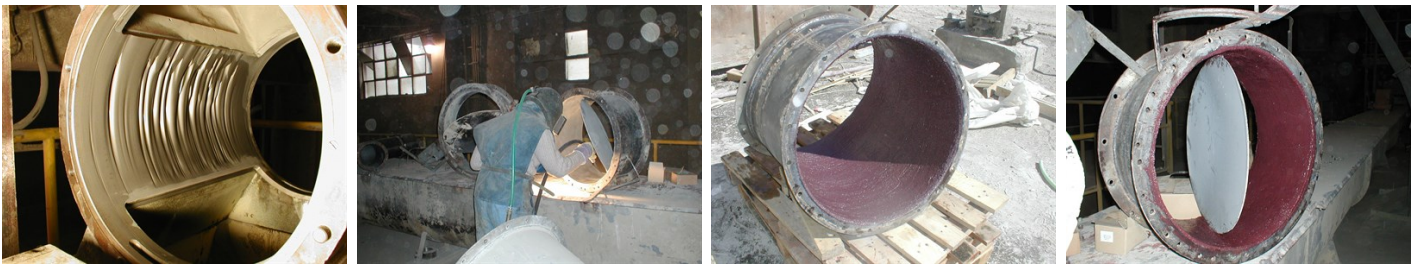
Photograph Descriptions

There was high abrasion caused by cement leading to local material loss of metal from valve body.

- * Badly eroded valve ,
- * Grit blasting the valves ,
- * Completed valve body ,
- * Re-assembled valve protected with Belzona® 1811 ,

Application was carried out in accordance with Belzona Know-How System Leaflet VPF-11.

The Belzona solution was initially accepted by customer because repair took only a few hours and the mill shut-down was very short. Since the first repairs in 2000 many more of these repairs have been completed.
