BELZONA SEALS SKYLIGHTS OVER PRODUCTION HALL

ID: 2456

Customer Location: *Machinery plant, Slovakia*

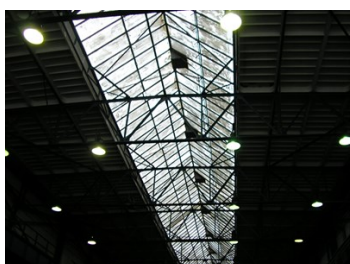
- * Skylights on the production hall ,
- * Corrosion of steel frame ,
- * Application in progress ,
- * The skylights in "as new" condition ,

Skylights in the roof of production hall

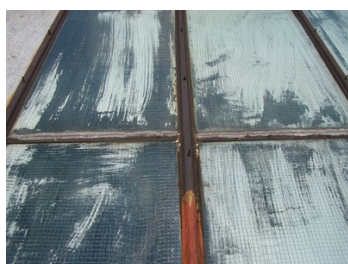
Corrosion of steel frame and rubber seal degradation on the skylights, caused by the effects of weather, was allowing rainwater to leak directly into the production hall creating safety issues and damage of interior machinery.

Application was carried out in accordance with Belzona Know-How System Leaflet RPA-3. A fully reinforced Belzona® 3111 system was applied to bridge over the glazing bars and seal onto the glass.
