# BELZONA RENEWS OLD PUMPS

ID: 2461

Customer Location: Power Plant, Croatia  
Application Date: 2011

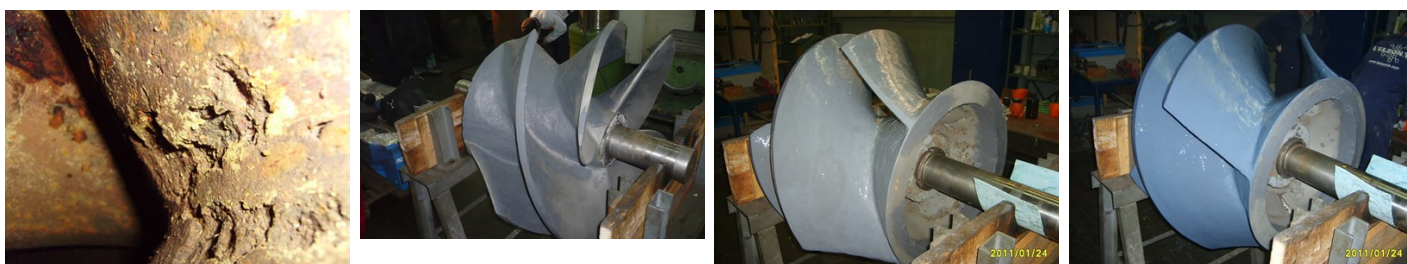
*When stripped down for inspection severe erosion damage on the impellers was found to be the cause of lost performance.*

- \* Up-close damage ,
- \* Rebuilding of the impeller profile ,
- \* Applying the first coat of Belzona® 1321 ,
- \* Impeller completed with a second coat of Belzona® 1321 ,

4 cooling water pump impellers which had been in service for 15 years.

Application was carried out in accordance with Belzona Know-How System Leaflets CEP-1 and CEP-3.

In 2007 the customer asked for renewal and protection of pump casings with Belzona® 1311 and Belzona® 1321. After 4 years in service the casings showed no significant wear. The customer was convinced of the quality of Belzona and ordered the renewal and protection of the impellers with the same Belzona system.
