BELZONA PROTECTS COOLING WATER PIPELINE

Customer Location: Power Plant, Croatia

Application: VPF-Valves, Pipes and Fittings

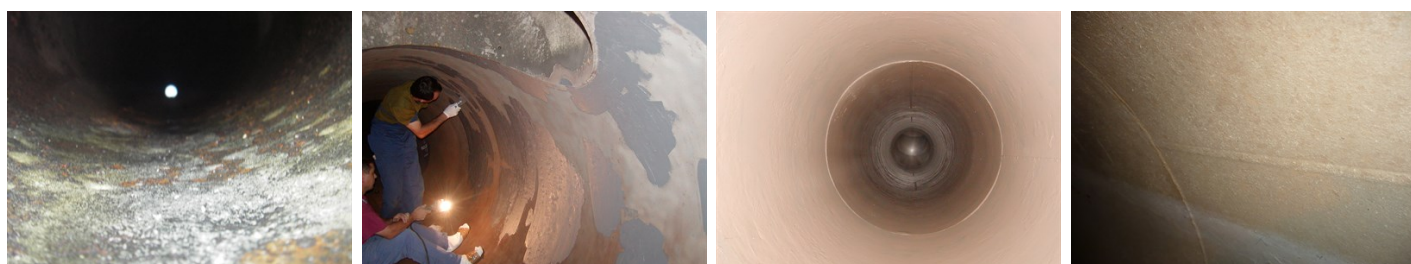
Photograph Descriptions

Pipe wall thickness measurement from outside showed heavy loss in material. The following visual inspection from inside confirmed the severity of the problem.

- * Corroded inner surface ,
- * Rebuilding lost profile ,
- * Belzona® 5811 applied as two coat system ,
- * Inspection after 3 years showed no damage ,

Application was carried out in accordance with Belzona Know-How System Leaflet VPF-1 and VPF-2. Belzona 1111 was used to rebuild the damaged profile and two coats of Belzona® 5811 applied for protection against organic organisms and sea water corrosion.

Belzona solvent free system was ideal for application in the confined space. Inspection of the coating after 3 years in service showed no damage at all. Even in 2011 (6 years in service) the coating is still performing well.
