# BELZONA SEALS FOUNTAIN LEAKS

**Customer Location:** Millennium Fountain, South West England

**Application:** FPA-Floor Problem Areas

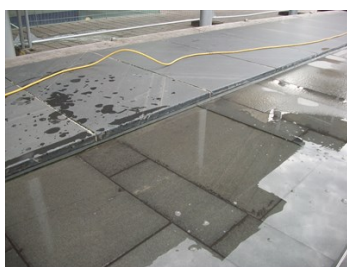
After 11 years of service the Millennium Fountain started to leak from between the base and the side wall interfaces within the pond areas. The water was leaking onto the pathways and staining the side walls of the fountain. Also the cost of the water loss was running into thousands of pound per year.

- \* Failed fillets within the fountain ,
- \* Building the new Belzona® 4111 fillets ,
- \* Belzona® 4111 fillets completed and the slate joint being filled with the slurry mix ,
- \* Completed application with the fountain refilled and back in use ,

The application was carried out in accordance with Belzona Know-How System Leaflet FPA-3. The existing failed rubber fillets were removed; the joints were then dried out and prepared to a good firm dry substrate. After carefully masking the area a fillet of Belzona® 4111 was applied between wall and floor in the pond areas. The Belzona® 4111 was tinted to match the slate colour. A slurry mix of Belzona® 4111 was also poured to seal between the slate slabs.
