BELZONA STOPS LEAKS IN HOT WATER TANK

ID: 2466

Customer Location: Power Plant Ljubljana, Slovenia
 Application Date: 1997

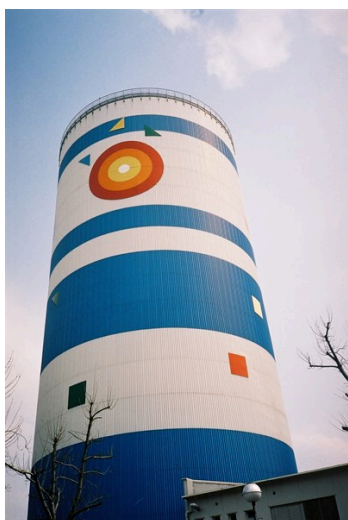
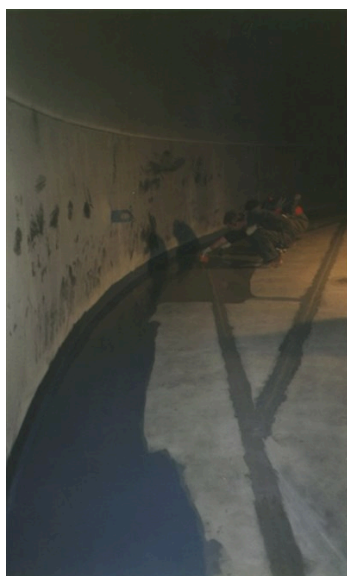
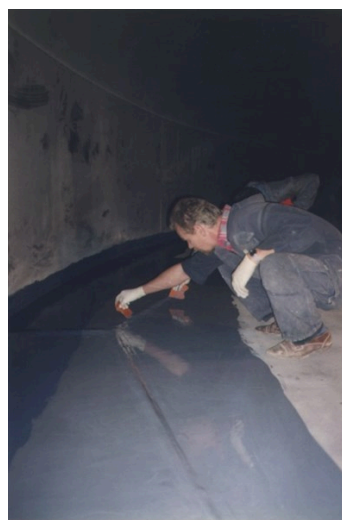
25 m diameter and 50 m high hot water tank. After initial inspection of the newly built tank, the welds connecting tank bottom steel plates were leaking.

- * Hot water tank ,
- * Applying Belzona® 1111 incorporating Reinforcement Tape ,
- * Applying Belzona® 1391 ,
- * Protected internal surface ,

Application was carried out in accordance with Belzona Know-How System Leaflet TCC-5. After reinforcing welds with Belzona® 1111 incorporating Belzona® 9341 (Reinforcement Tape), Belzona® 1391 was applied to provide corrosion protection to the whole internal bottom surface.
