# BELZONA SECURES THE TOWN HALL STEPS

ID: 2477

Customer Location: Town hall, France  
Application Date: February 2006

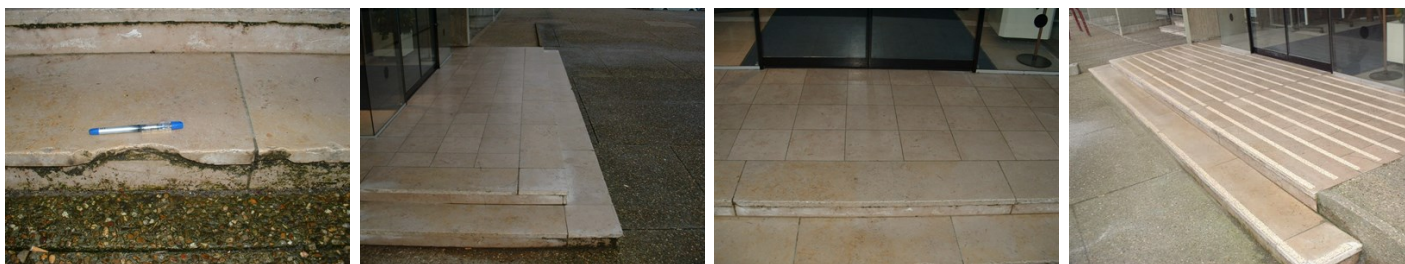
*The steps were damaged through impact and were extremely slippery when wet.*

- \* Close view of the damaged steps ,
- \* Side view of the steps ,
- \* Steps rebuilt with Belzona® 4111 ,
- \* Completed application with Belzona® 4411 grip system applied to leading edges ,

The application was carried out in accordance with Belzona Know-How System Leaflets FPA-8 & FPA-1. The steps were rebuilt with Belzona® 4111. A 3cm wide strip of Belzona® 4411 grip system was applied to the leading edge of the steps to create a non-slip surface.
