BELZONA REPLACES NON-SLIP TAPES ON RAMP

ID: 2479

Customer Location: *Hospital, France*
 Application Date: *February 2003*

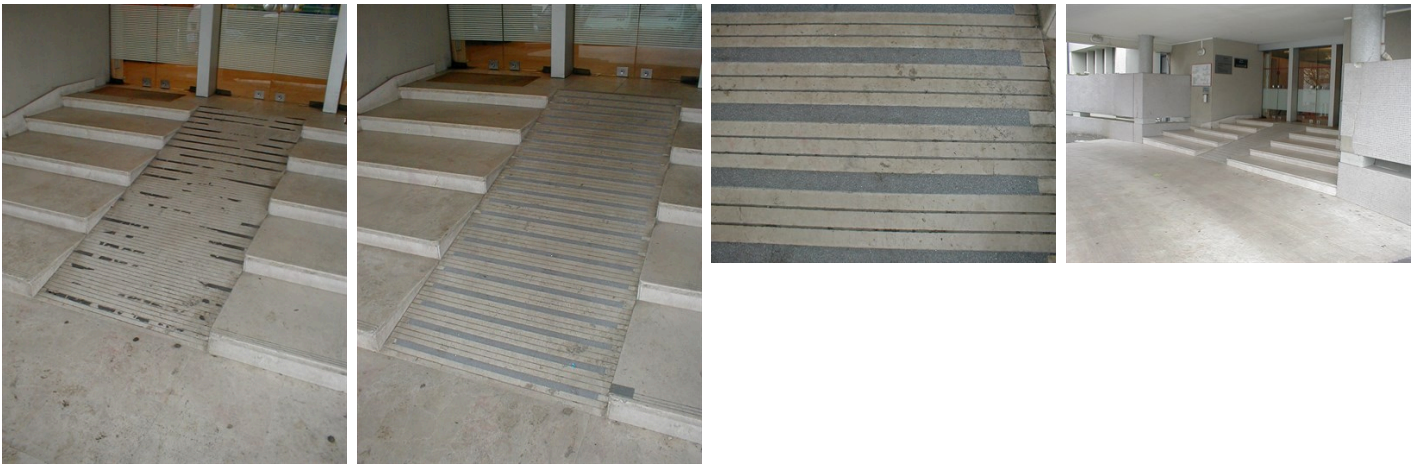
The ramp was a potential slip hazard and adhesive tapes had been unsuccessfully used to create a non-slip surface. A more positive, long term solution was required.

- * Ramp with failed tape system clearly evident ,
- * Ramp after application of Belzona® 4411 ,
- * Close view of the application ,
- * General view of the ramp at the hospital entrance ,

Application was carried out in accordance with Belzona Know-How System Leaflet FPA-8.

After the application, the ramp is as new and safe for pedestrians. This application is reported to still be in perfect condition in 2012.
