BELZONA SEALS RE-DESIGNED WORKSHOP ROOF

ID: 2486

Industry: General Industry
Application: RPA-Roof Problem Areas
Substrate: Clad Steel Roof
Products: * Belzona® 3131 (WG Membrane) ,

Customer Location: Train operator, Newcastle, UK
Application Date: September 2011

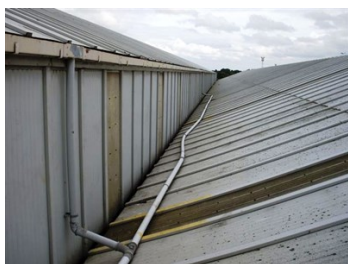
Heavy rainfall resulted in flooding within the workshop area. In addition, the drain pipes within the valley gutter were completely blocked.

- * Leaking Roof Area ,
- * Fabricated steel panels being installed ,
- * Belzona® 3131 applied to the panels ,
- * Total encapsulation ,
