# BELZONA ANGLE IRON BONDED INTO PLACE

ID: 25

Customer Location: Oil Refinery in Canada

Application Date: September 1998

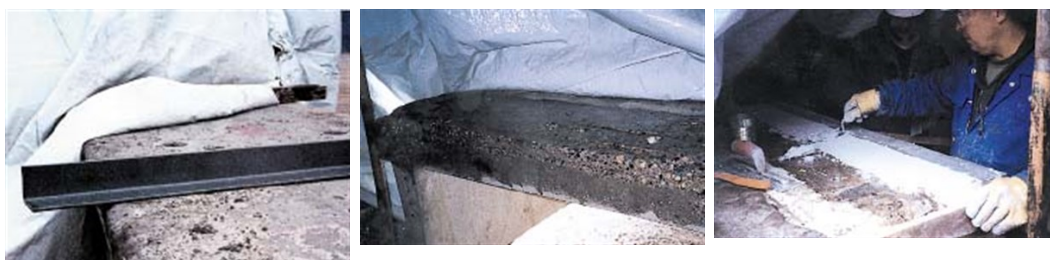
Concrete severely eroded. Exit end of concrete beam damaged by the impact of the scale bumping into the end of the scale sump wall.

- \* Piece of 4 x 4 1/4 inch angle iron is prepared to be bonded into place. ,
- \* Substrate conditioned with Belzona® 4911 (Magma TX Conditioner). ,
- \* Angle iron strongly bonded into place with Belzona® 4111(Magma- Quartz). ,

Application was carried out in accordance with a modified version of Belzona Know-How Leaflet FPA-5.

The Belzona system was chosen for its high adhesion, compressive strength, impact resistance and chemical resistance to hot asphalt oil which is occasionally spilled on the surface of the scale.
