# PRESS ROLL REPAIR WITH BELZONA

**Industry:** *Pulp & Paper*  
**Application:** *TCC-Tanks and Chemical Containment Areas*  
**Substrate:** *Steel*  
**Products:** *\* Belzona® 1111 (Super Metal) ,*  
*\* Belzona® 1341 (Supermetalglide) ,*

**Customer Location:** *Pulp and paper mill, Germany*  
**Application Date:** *July 2008*

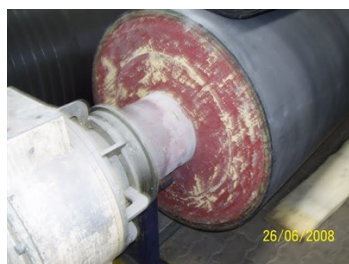
*Corrosion had led to perforation of side plates.*

- \* Corroded side plate ,
- \* Grist-blasted side plate ,
- \* Application of Belzona® 1111 ,
- \* Completed application ,
