# BELZONA KEEPS THE TRAFFIC MOVING: FOUR YEARS AND GOING STRONG

ID: 262

Valve well cover ring seat, located on a busy road.

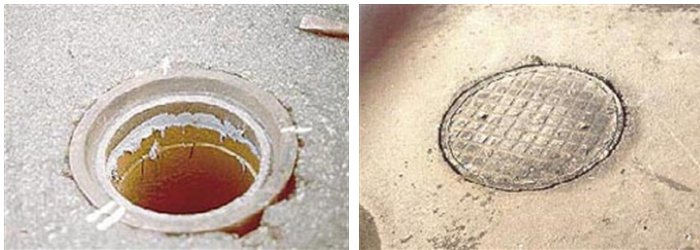
*Continuous impact from traffic damaged the outer concrete ring seat causing problems. The traffic could not be disrupted for an extended period of time.*

- \* Close look at the damage prior to Belzona repair ,
- \* Completed job, still in service after four years ,

The application was carried out in accordance with a modified version of Belzona Know-How System Leaflet GSS-7.

The Belzona solution allowed the city to reset the valve well and manhole covers before further damage occurred, with the least amount of material and traffic disruption.
