BELZONA EMERGENCY RECLAMATION OF REFINER

ID: 266

Industry: *Pulp & Paper*
Application: *PDP-Positive Displacement Pumps*

Customer Location: *Paper mill in the United Kingdom*
Application Date: *August 2000*

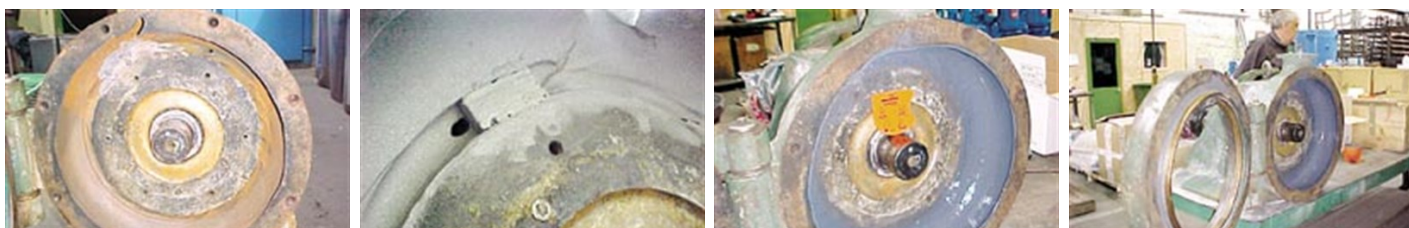
Photograph Descriptions

Severe erosion in the refiner body and the end cover/door led to several holes in the casing necessitating repair.

- * The refiner casing prior to preparation ,
- * After grit blasting, the damage and several holes were clearly evident ,
- * The repaired casing ,
- * The end cover/door was also fully refurbished ,

The application was carried out in accordance with Belzona Know-How System Leaflet PDP-6.

Belzona had already been used in an emergency to seal a leak in the casing. During a scheduled three-day shut down a permanent repair was completed with Belzona® 1311. Then a protective coating with Belzona® 1321 was applied to this critical piece of equipment.
