BELZONA REPAIRS AND PROTECTS SULFURPRILL TOWER

ID: 270

Customer Location: Oil refinery in Saudi Arabia
Application Date: August 2001

Prill tower for pelletizing sulfur.

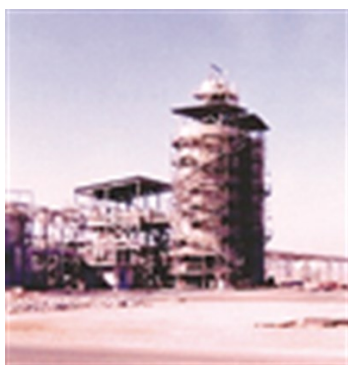
Acidic content of moist sulfur had led to sever attack of the concrete.

- * General view of the tower ,
- * Cracks and damaged concrete required extensive repairs with Belzona® 4111 ,
- * Steel/concrete joint sealed ,
- * Application of Belzona® 5811 underway ,

Belzona Systems allowed the tower to be repaired and protected quickly and effectively ensuring many years of continued service. The stainless steel cone in the base of the tower was not coated, but the Belzona provides an excellent seal at the steel/concrete interface. Belzona Systems were also used on the external surfaces to provide additional protection from the marine atmosphere.
