BELZONA SEALS LEAKING FLANGE

ID: 2713

Customer Location: Chemical plant, Germany
Application Date: May 2010

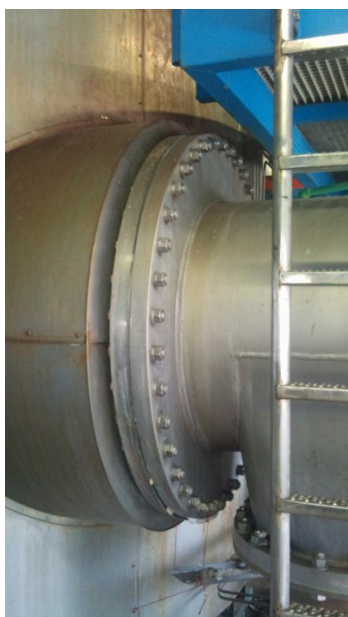
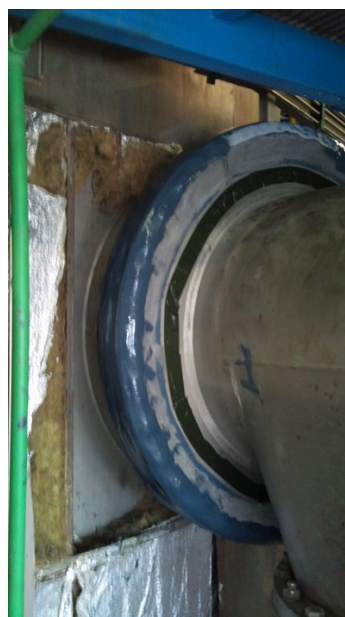
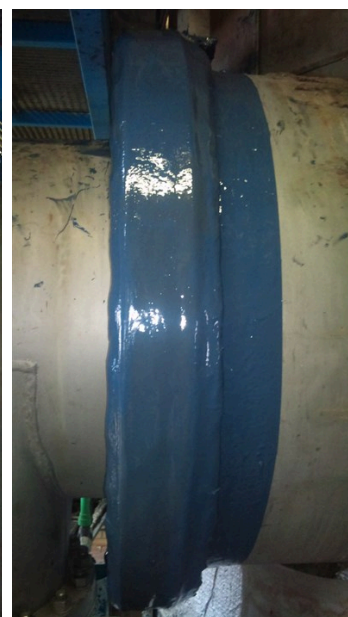
Flanged joint was leaking at the gasket and through the bolts. Customer required an in-situ repair to seal the leak as joint could not be dismantled to effect a conventional repair.

- * Leaking flange ,
- * Belzona® 1111 applied to bolts ,
- * First coat of Belzona® 1391 applied ,
- * Completed application ,

Application was carried out using a modified version of Belzona Know-How System Leaflet VPF-11. The surface was prepared by grit blasting. The bolts were fully encapsulated using Belzona® 1111 to seal the leaks in these areas. Following this Belzona® 1391 incorporating Reinforcement tape was used to completely encapsulate the flange joint.

The Belzona products were chosen to withstand the high process temperatures (120°C) and have proven to be totally effective leading to several similar repairs at the facility.
