# BELZONA SEALS LEAKING FLANGE

Industry: Chemical & Petrochemical  
Application: VPF-Valves, Pipes and Fittings  
Substrate: Steel  
Products: \* Belzona® 1391 (Ceramic HT) ,  
\* Belzona® 1111 (Super Metal) ,

Customer Location: Chemical plant, Germany  
Application Date: May 2010

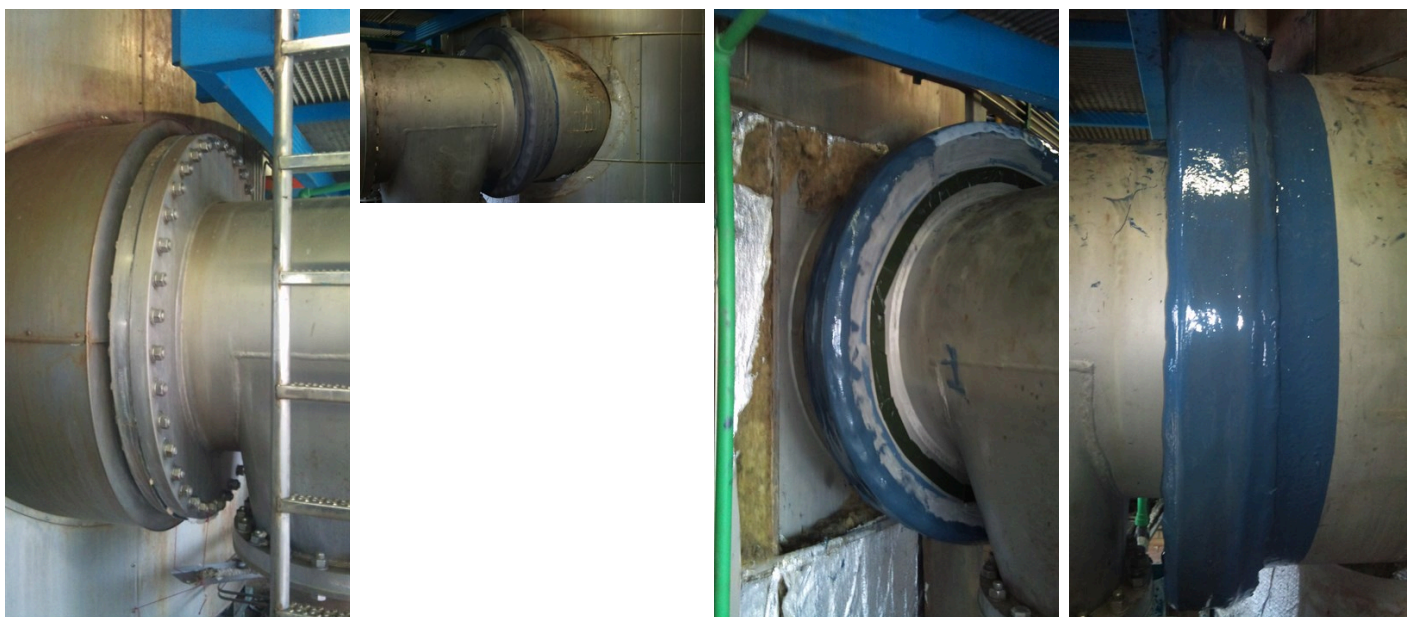
Flanged joint was leaking at the gasket and through the bolts. Customer required an in-situ repair to seal the leak as joint could not be dismantled to effect a conventional repair.

- \* Leaking flange ,
- \* Belzona® 1111 applied to bolts ,
- \* First coat of Belzona® 1391 applied ,
- \* Completed application ,

Large flange in hot brine process system

Application was carried out using a modified version of Belzona Know-How System Leaflet VPF-11. The surface was prepared by grit blasting. The bolts were fully encapsulated using Belzona® 1111 to seal the leaks in these areas. Following this Belzona® 1391 incorporating Reinforcement tape was used to completely encapsulate the flange joint.

The Belzona products were chosen to withstand the high process temperatures (120°C) and have proven to be totally effective leading to several similar repairs at the facility.
