BELZONA PROVES TO BE THE MATERIAL FOR CHEMICAL CONTAINMENT AREAS

ID: 272

Customer Location: Chemical refinery in Western North Carolina, USA.

Application: TCC-Tanks and Chemical Containment Areas

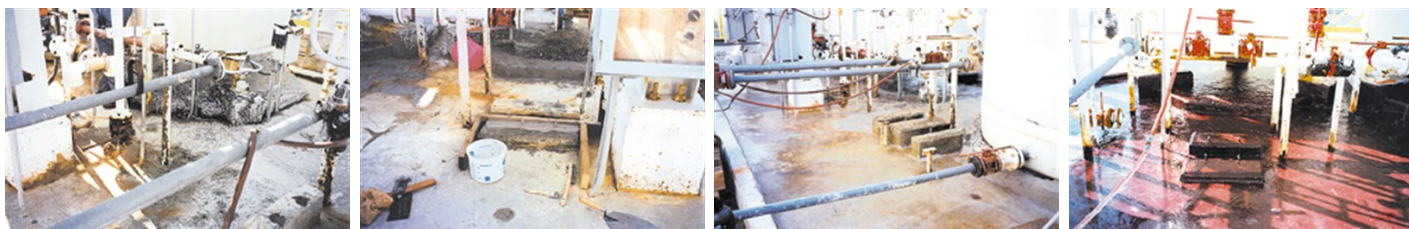
Photograph Descriptions

Repetitive exposure to concentrated hydrochloric and hydrofluoric acids, which eroded the concrete substrate.

- * The area has been cleaned/degreased Belzona® 4131 is being used to rebuild the eroded areas ,
- * Belzona® 4911 has been applied prior to the final coating ,
- * The completed application. ,

The application was carried out in accordance with Belzona Know-How System Leaflet TCC-9, TCC-15.

At least five imitation products had failed to protect the containment area prior to Belzona. Belzona® 4131 was used to rebuild the eroded areas, and Belzona® 4311 was used to coat the entire containment area.
